# Cleaning Efficiency Analysis for the "ProfilGate" Tyre Cleaning System

Offer No.: 14 04 337 14

**Department for micro-production**

**Fraunhofer IPA, Stuttgart**

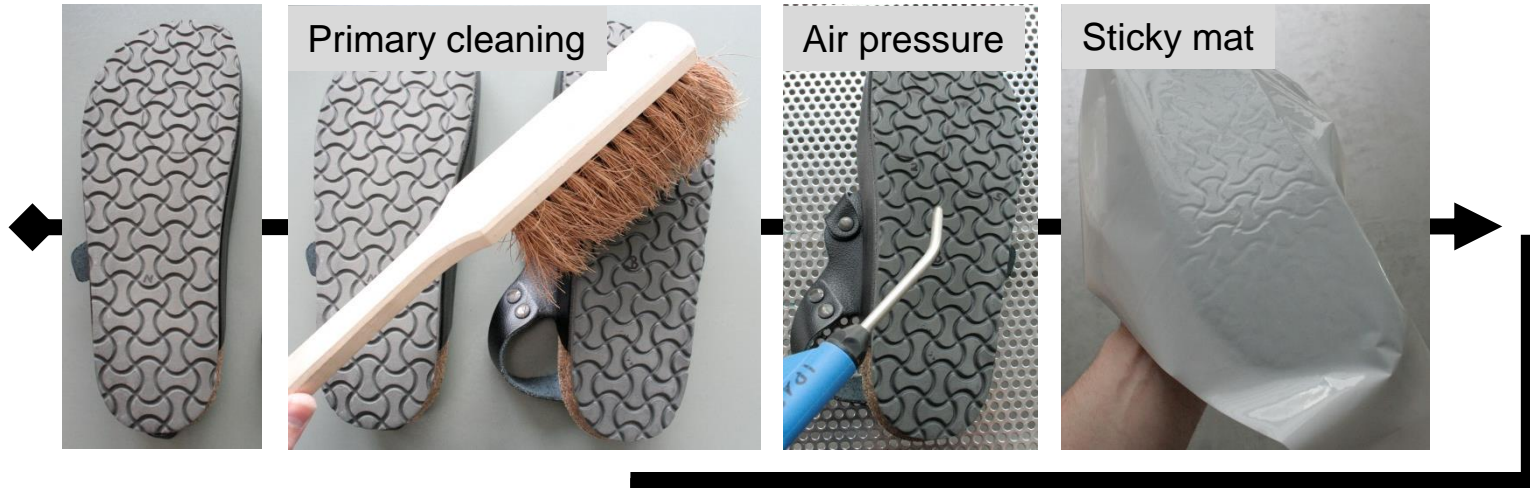
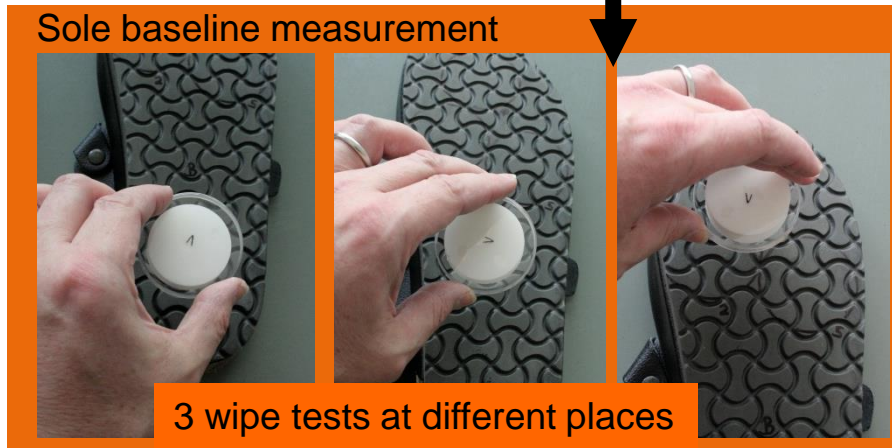
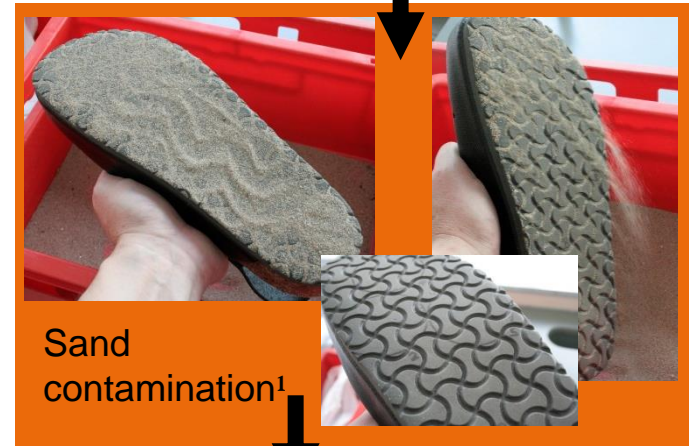
# 1.1. Microscopic evaluation Sole cleaning

Use of ProfilGate, after wipe test (like base measurement)

<sup>1</sup> Walking on sand causes an inhomogeneous allocation of the sand on the sole.

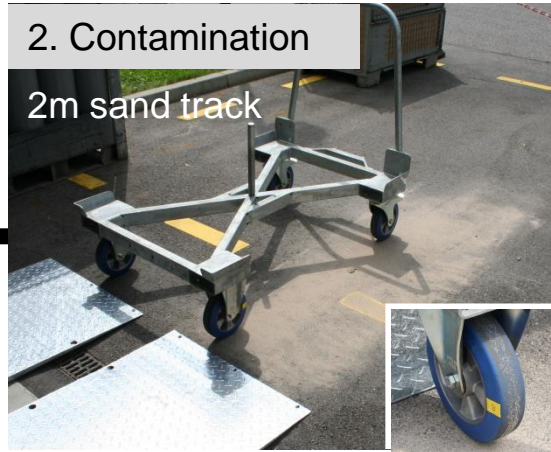
2. Contamination

2m sand track

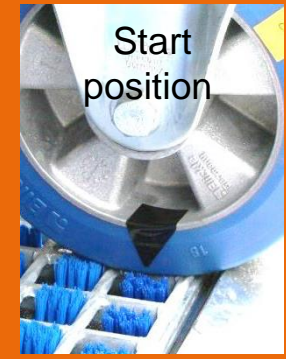
4. Labelling

Start position

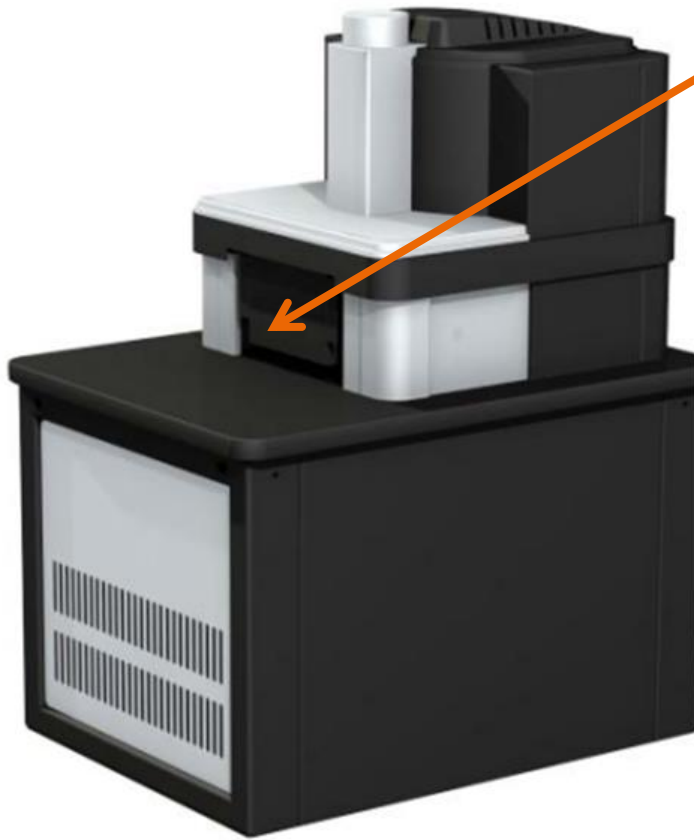
**Manufacturer:** RJL  
**Model:** PSEMeXplorer

1. Insertion of wipe tests.

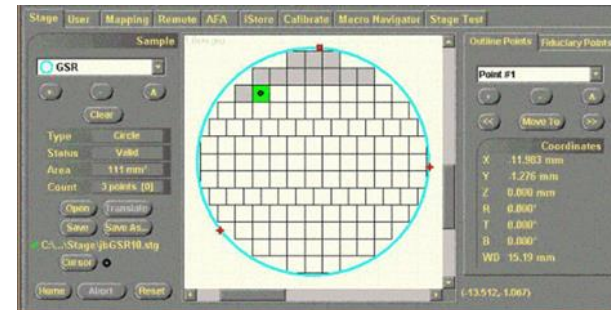
2. Scanning and evaluating the wipe Tests for dirt / contamination

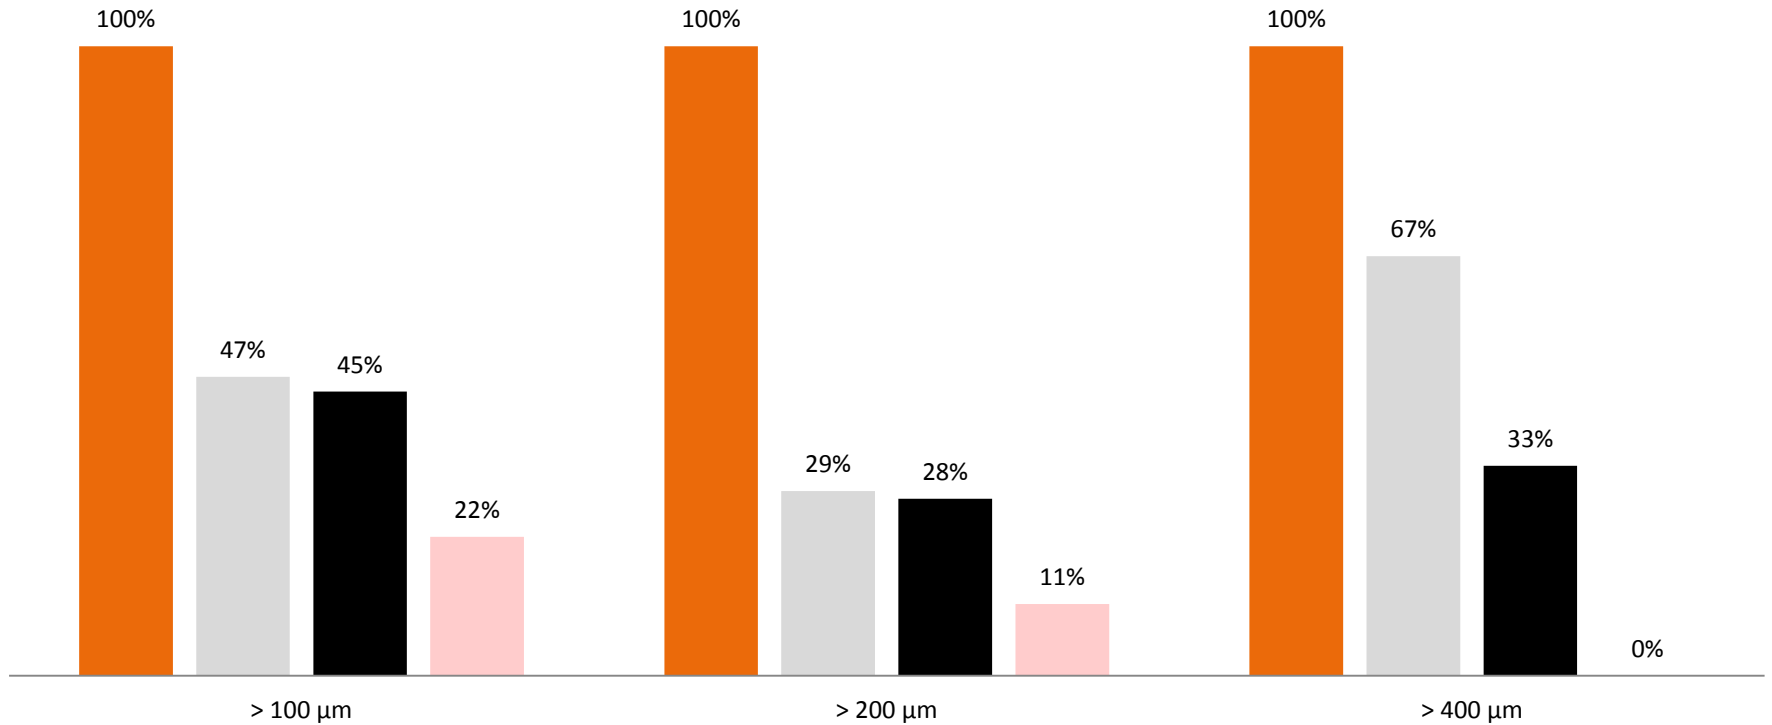
## 2.1 REM-EDX evaluation of sole cleaning Shoe wipe test

### Shoe

■ Sand contaminated ■ 2 steps ■ 5 steps ■ 10 steps

> 100 µm	> 200 µm	> 400 µm
Sand contaminated	2328	167	3
2 steps	1105	49	2
5 steps	1051	47	1
10 steps	514	19	0

> 100 µm	> 200 µm	> 400 µm
	100%	100%	100%
	47%	29%	67%
	45%	28%	33%
	22%	11%	0%

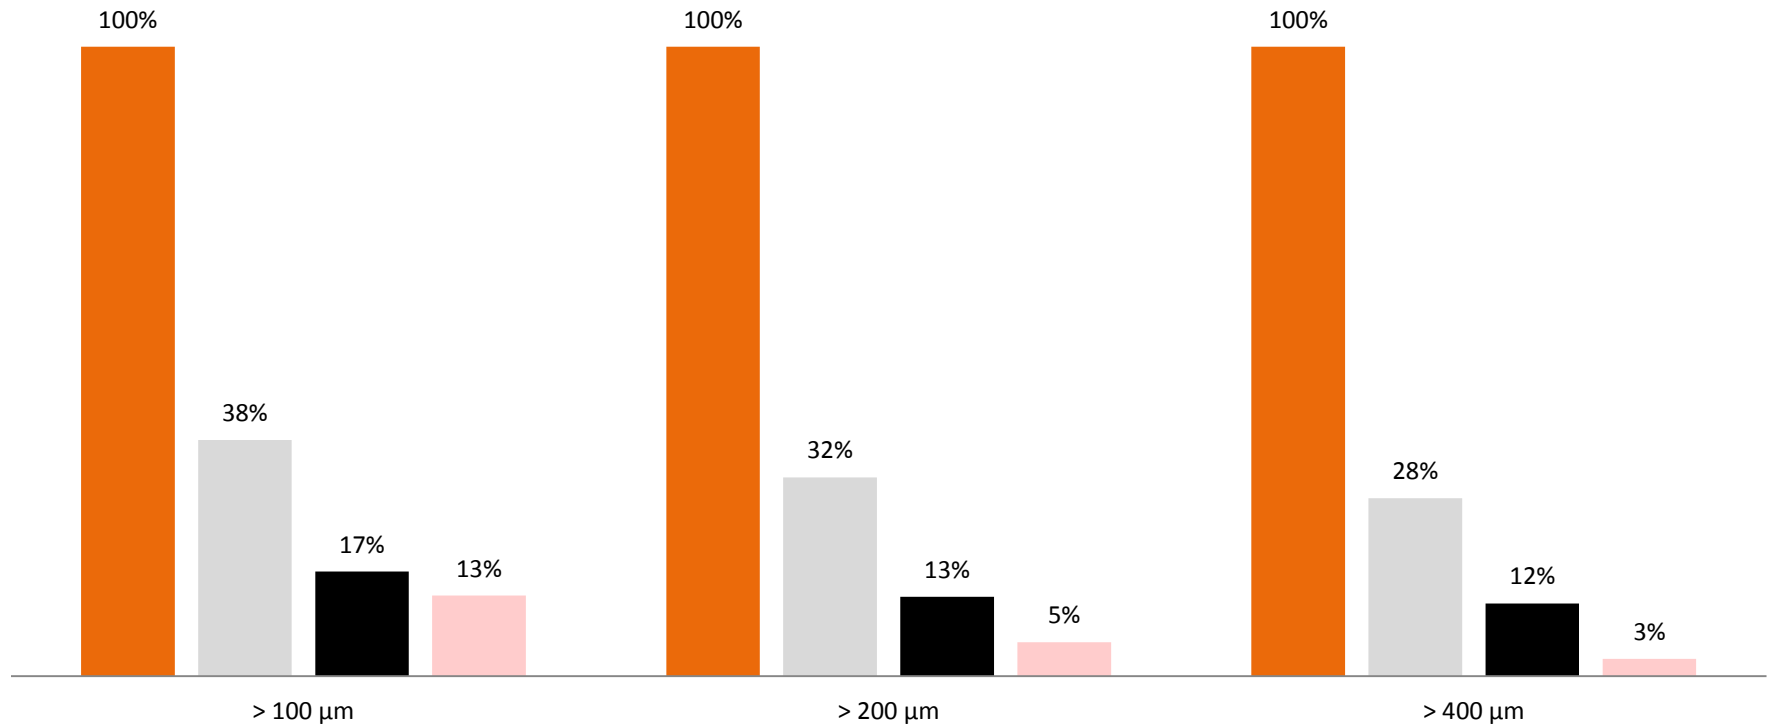
## 2.2 REM-EDX evaluation of tyre cleaning Forklift wipe test

### Forklift

■ Sand contaminated   ■ 3 wheel turns   ■ 6 wheel turns   ■ 9 wheel turns

> 100 µm	> 200 µm	> 400 µm		> 100 µm	> 200 µm	> 400 µm
Sand contaminated	999	871	329	→	100%	100%	100%
3 wheel turns	375	275	93		38%	32%	28%
6 wheel turns	166	110	38		17%	13%	12%
9 wheel turns	128	47	9		13%	5%	3%

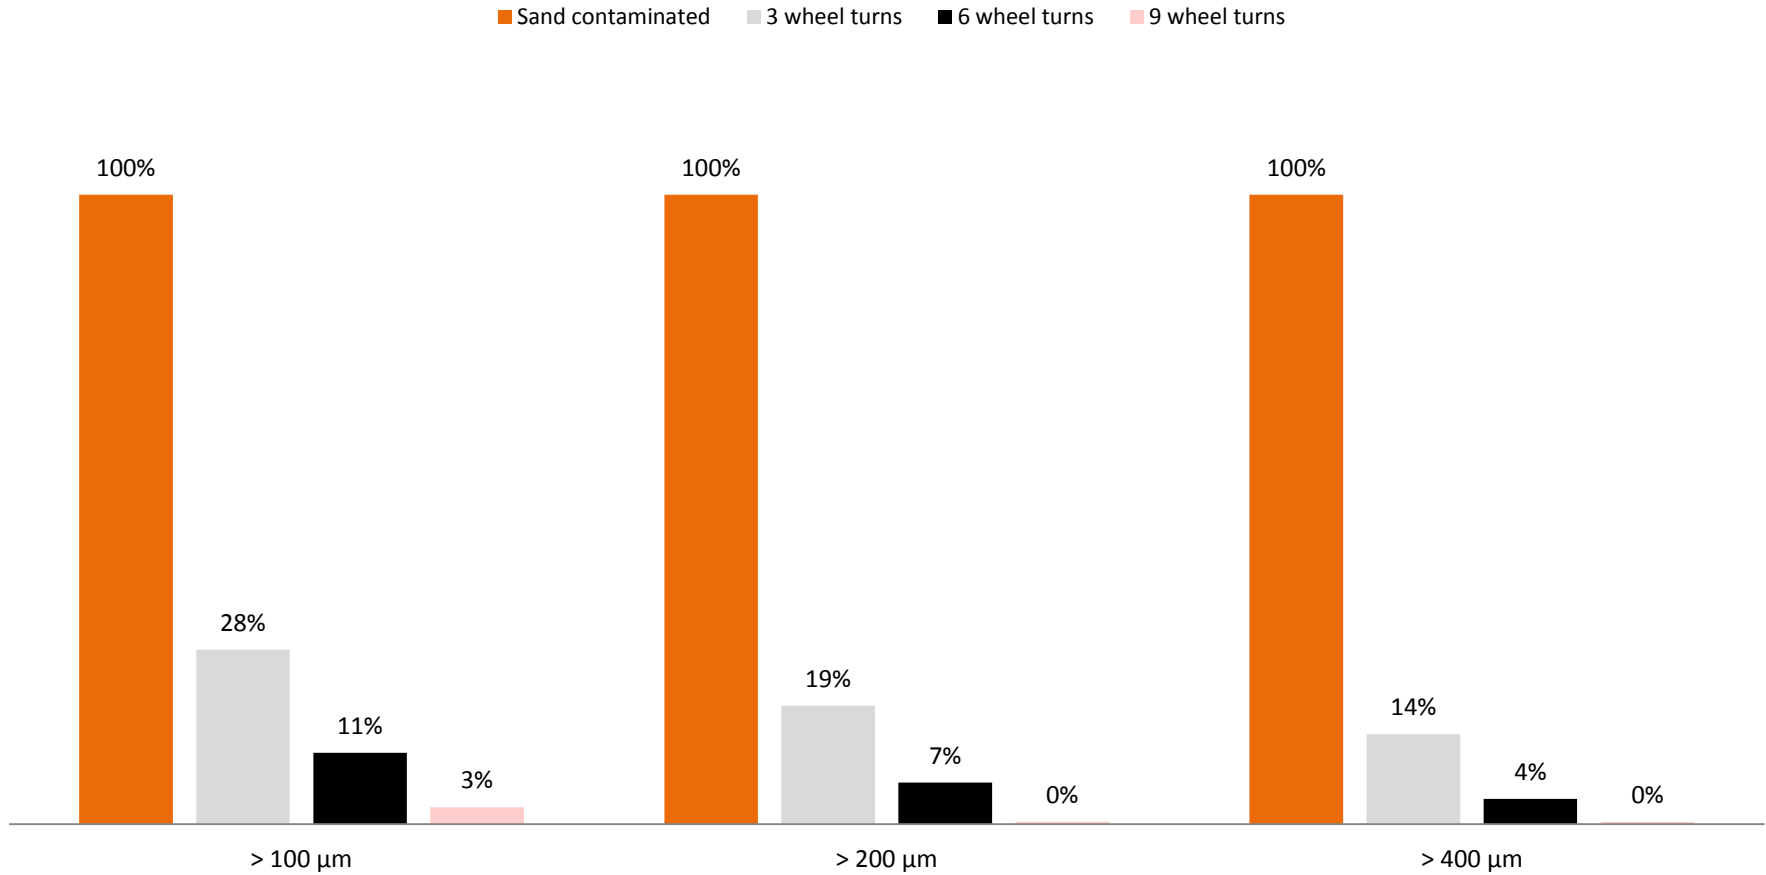
## 2.3 REM-EDX evaluation of tyre cleaning Trolley wipe test

Trolley

> 100 µm	> 200 µm	> 400 µm
Sand contaminated	556	515	273
3 wheel turns	154	97	39
6 wheel turns	63	34	11
9 wheel turns	15	2	1

> 100 µm	> 200 µm	> 400 µm
Sand contaminated	100%	100%	100%
3 wheel turns	28%	19%	14%
6 wheel turns	11%	7%	4%
9 wheel turns	3%	0%	0%
